MTL TN 90-2

MECHANICAL BEHAVIOR OF A SiC-FIBER/Si₃N₄ COMPOSITE

September 1990

ABSTRACT

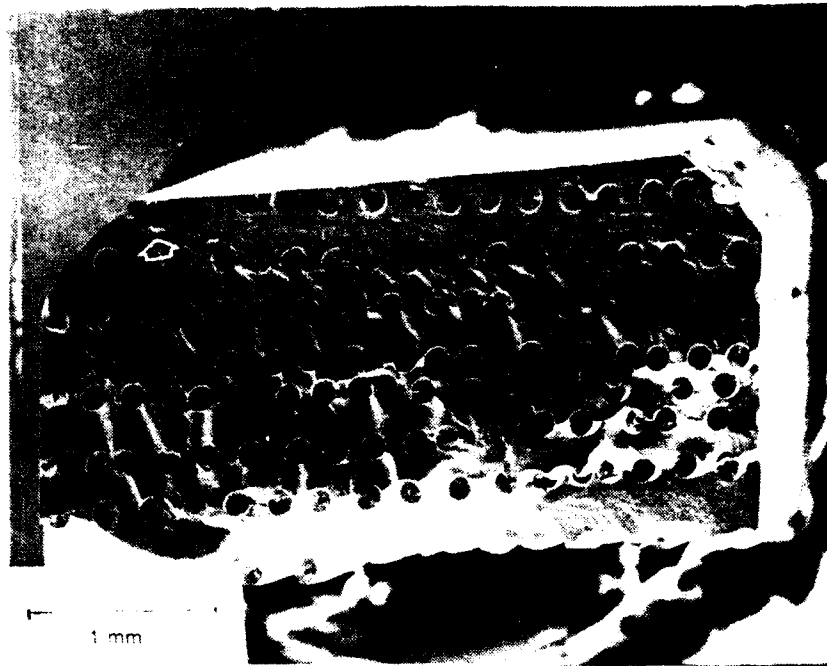
Figure 9a. Fracture surface from the SR test. Arrow indicates failure origin. Tensile surface is at the top of the photo.

Fractographic analysis of the SR specimens also showed a clear failure origin. In one case, failure occurred due to a porous region ≈100 μm in size, as shown in Figure 9. The previous work here has shown that when the fibers are exposed on the surface, the failure will initiate in this area during room temperature testing. However, in this instance the failure originates in the matrix below a layer of exposed fiber even though the fibers are larger than the flaw, ≈125 μm versus ≈100 μm. This indicates that there is now a strong bond between the fiber and matrix, such that the material acts like a monolithic piece when the crack propagates through the specimen.
